SHOULD STAINLESS STEEL ALLOYS BE USED AS BUFFER LAYERS ON AMS FROG REPAIR?

Examination of a failed frog reveals that 312 Stainless Steel buffer layers can lead to catastrophic failures.

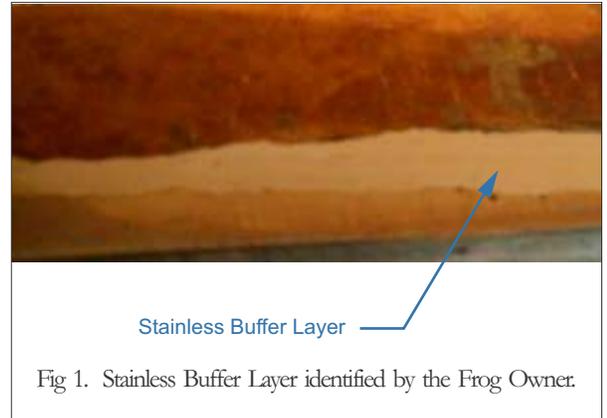
Fig 1. Stainless Buffer Layer identified by the Frog Owner.

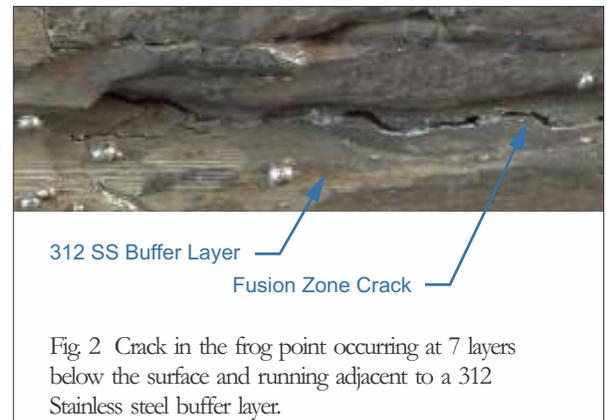
In November 2015, a frog with a severe breakout of the point was field sectioned and shipped to the lab for analysis. Upon arrival in the lab, the broken out section was further sectioned for microscopic analysis. Fig 2 shows a distinct crack running lengthwise along the frog section. Its distinct color indicated that this deposit was not the typical AMS welding electrode/wire deposit. Further investigation with the frog owner confirmed our suspicions that this deposit was in fact a 312 Stainless Steel electrode applied buffer layer (see Fig. 3). The crack appeared to run on the fusion line between the AMS frog base metal and 312 Stainless weld metal and occasionally ran along the fusion line between the 312 Stainless buffer layer and the AMS build up wire deposit. Photomicrographs in Fig 4 confirmed this observation. Upon further investigation under high magnification, small chromium carbides were noted along the fusion zones base metal and AMS buildup. It was determined that these chromium carbides were a major contributor to the frog failure. Chromium carbides are the result of carbon and chromium combining into a very angular hard compound, known as a chromium carbide, which can be helpful in abrasion resistance, or in this case, a very harmful source of cracking. But where did they come from?

Fig 2 Crack in the frog point occurring at 7 layers below the surface and running adjacent to a 312 Stainless steel buffer layer.

Should stainless steel alloys be used as buffer layers on AMS frog repair? All stainless steels contain high volumes of chromium which contributes to the formation of chromium carbides and its use is not recommended by Postle Industries, Inc.

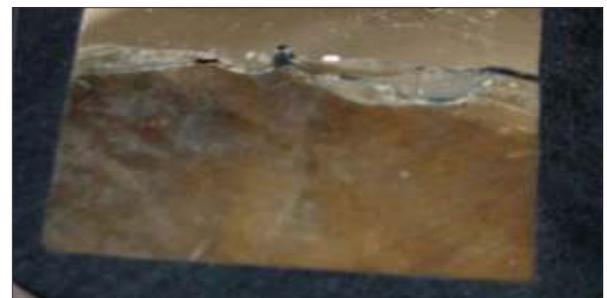
Fig 3 Mounted cross section of the failed frog showing a crack running in the fusion zone of AMS frog and 312 Stainless steel buffer layer.

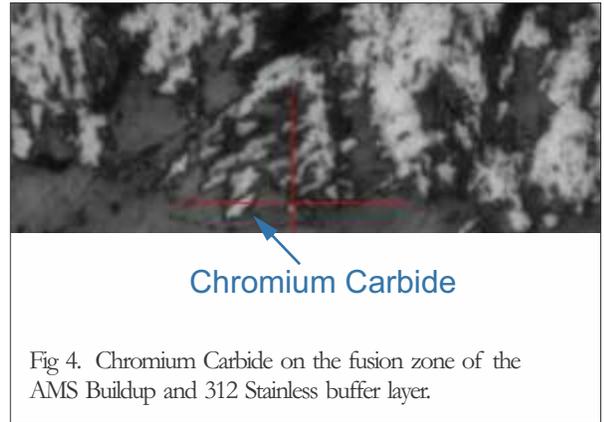
Fig 4. Chromium Carbide on the fusion zone of the AMS Buildup and 312 Stainless buffer layer.

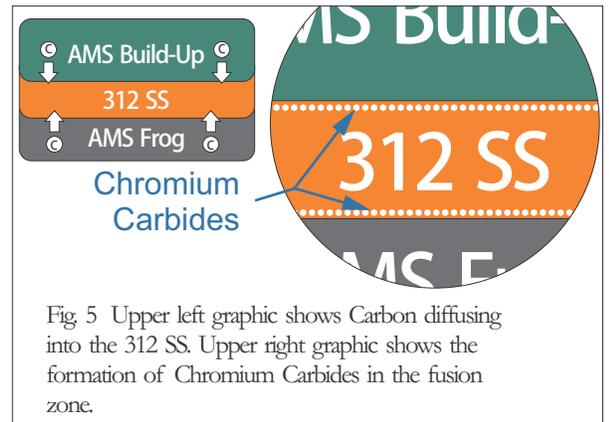
So how did the formation come about to cause such a catastrophic failure? We know that carbon, being quite small in size, likes to migrate, especially when heat is applied to the base and weld metal, to areas that are void of carbon. We also know that the carbon will cross fusion zones to get where they are going, but they will also link up with chromium almost instantly if any is encountered in the migration. Keeping these things in mind, imagine that a layer of 312 Stainless deposit is a buffer layer on top of the broken out AMS frog (see Fig. 5). Through the dilution with the AMS frog base material, a large volume of carbon now exists in the 312 Stainless Steel buffer deposit. In addition, carbon from the AMS Frog and AMS build-up migrates into the 312 Stainless steel buffer layer, aggravating the situation. The carbon migration is further enhanced by the successive layers of AMS build-up applied during the build up procedure. Keeping low interpass temperatures below 500°F (260°C) helps to retard, but not eliminate this migration and formation of chromium carbide as well as other harmful carbides. It was also noted that once the 312 Stainless deposit ended further back on the point, the crack also ended, suggesting further that the crack is associated with the 312 Stainless buffer layer.

Fig 5 Upper left graphic shows Carbon diffusing into the 312 SS. Upper right graphic shows the formation of Chromium Carbides in the fusion zone.
